3.0 Affected Environment, Environmental Impacts and Mitigation

3.1 Aesthetics (I)

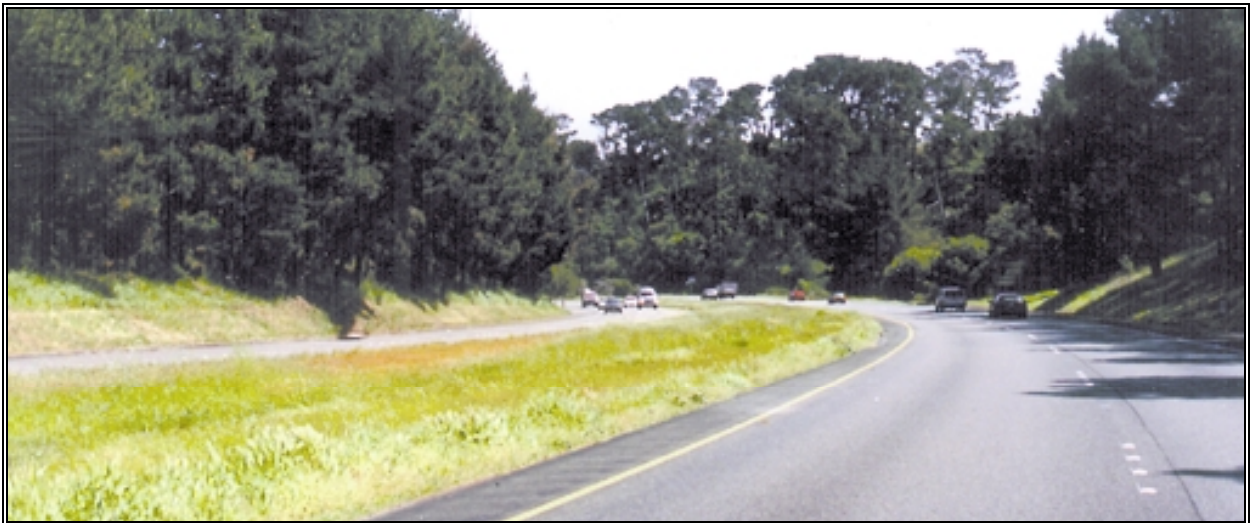
Observer Viewpoint #1

Existing—This viewpoint represents how the project area appears to northbound highway travelers between Iris Canyon Road and Aguajito Road Undercrossings. The road alignment through the narrow vegetated corridor is in visual harmony with the landform. The curve in the roadway along with the densely vegetated sloped shoulders obtains an above average rating for all three visual quality criteria; vividness, intactness, and unity.

<u>Viewpoint #1</u>	<u>Vividness / Intactness / Unity = Visual Quality (VQ=V+I+U/3)</u>				
Existing	5.9	5.7	5.8	=	5.8
Proposed	5.5	5.1	5.4	=	5.3
Visual Quality Difference				=	-0.5

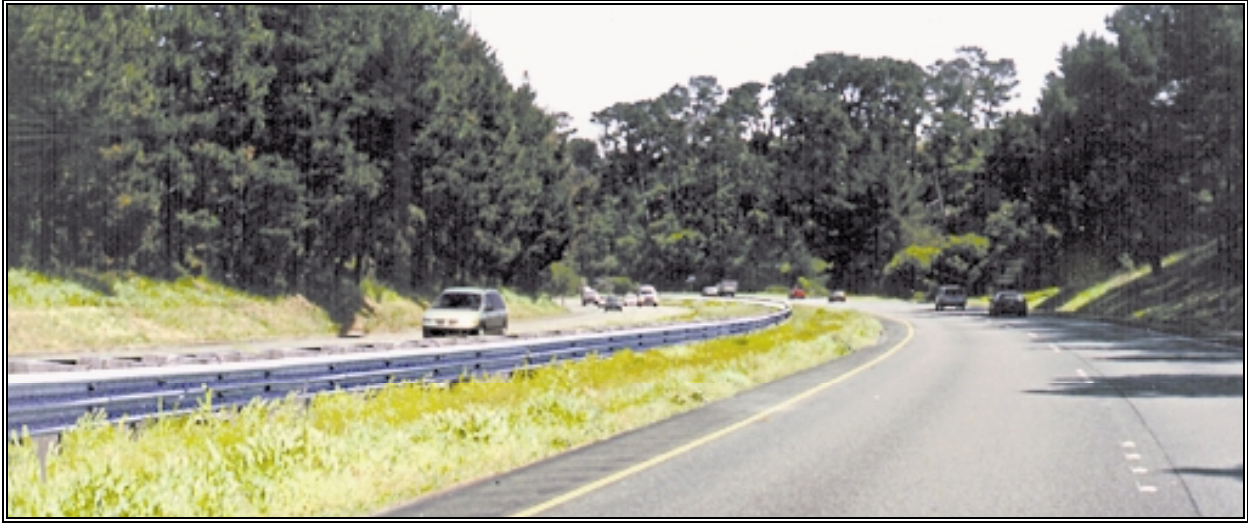
Observer Viewpoint #1

Proposed—The proposed improvement represents how a double white beam installed in the center of the median would appear to highway travelers. The introduction of another vertical man-made form would somewhat disrupt the valley corridor character. The roadway vividness and unity would slightly be reduced. While intactness would experience a moderate reduction rating due to the break in valley vegetation continuity.

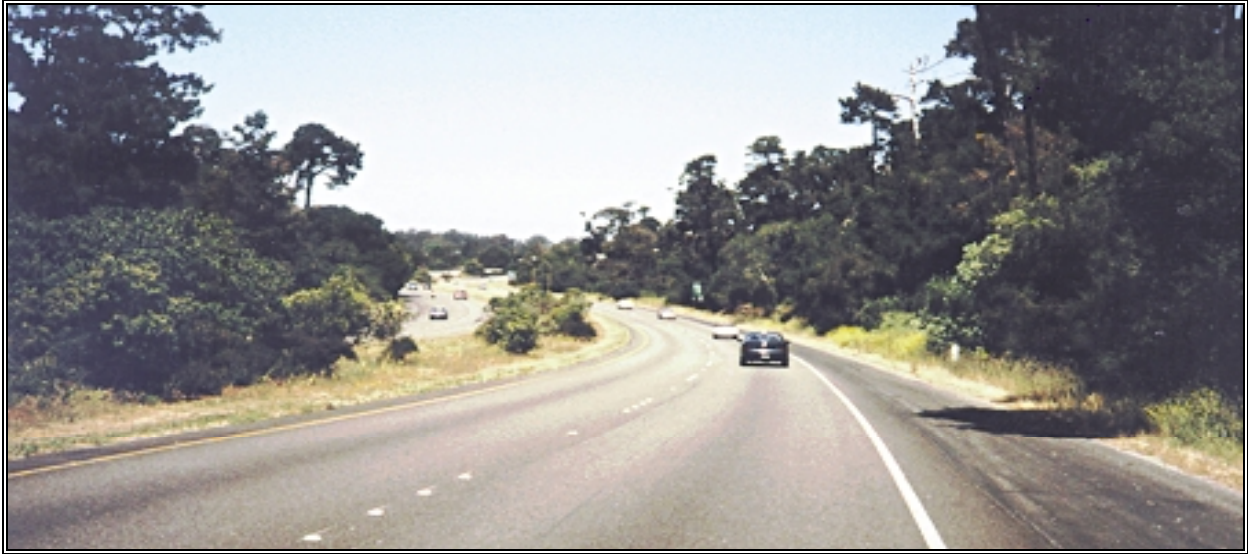
Observer Viewpoint #2

Existing—This viewpoint represents how the project area appears to northbound highway travelers approaching the Aguajito Road Exit. The narrow corridor decreases in elevation and reveals the valley. Long-range views to Monterey Bay are complemented with dense foreground planting resulting in a high rating of vividness. Intactness and unity are somewhat compromised due to the influence of development viewed in the valley floor and the corridor.

Viewpoint #2	Vividness / Intactness / Unity			= Visual Quality (VQ=V+I+U/3)	
Existing	5.8	5.5	5.7	=	5.7
Proposed	5.3	5.1	5.2	=	5.2
Visual Quality Difference				=	-0.5

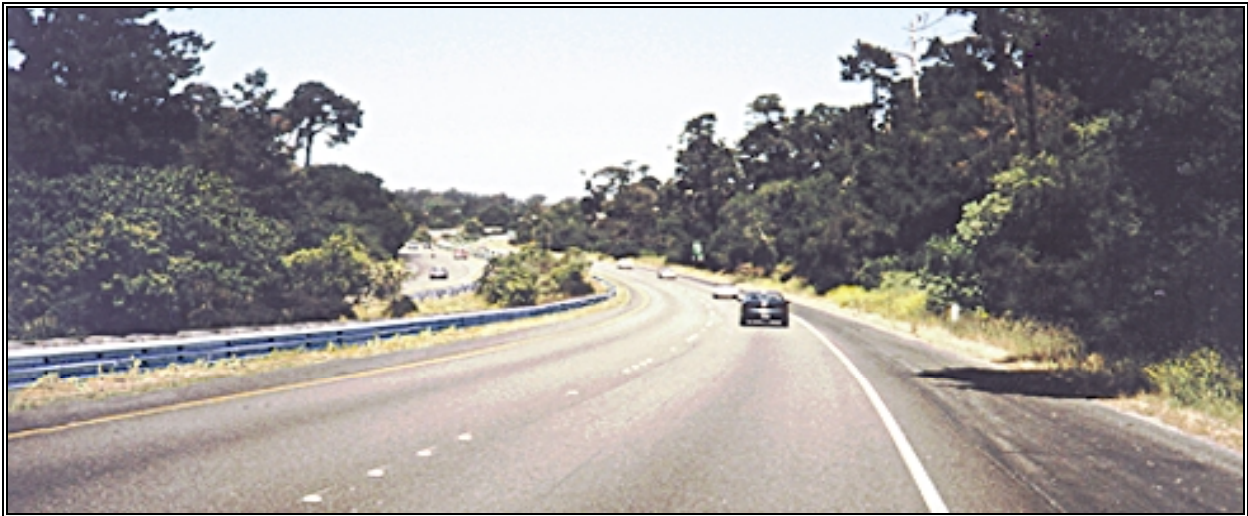
Proposed—The proposed improvement illustrates single three beam at the edge of inside shoulders protecting the existing plantings. The barrier would disrupt the visual rhythm of the opening and closing of views causing all three visual criteria ratings to decrease.

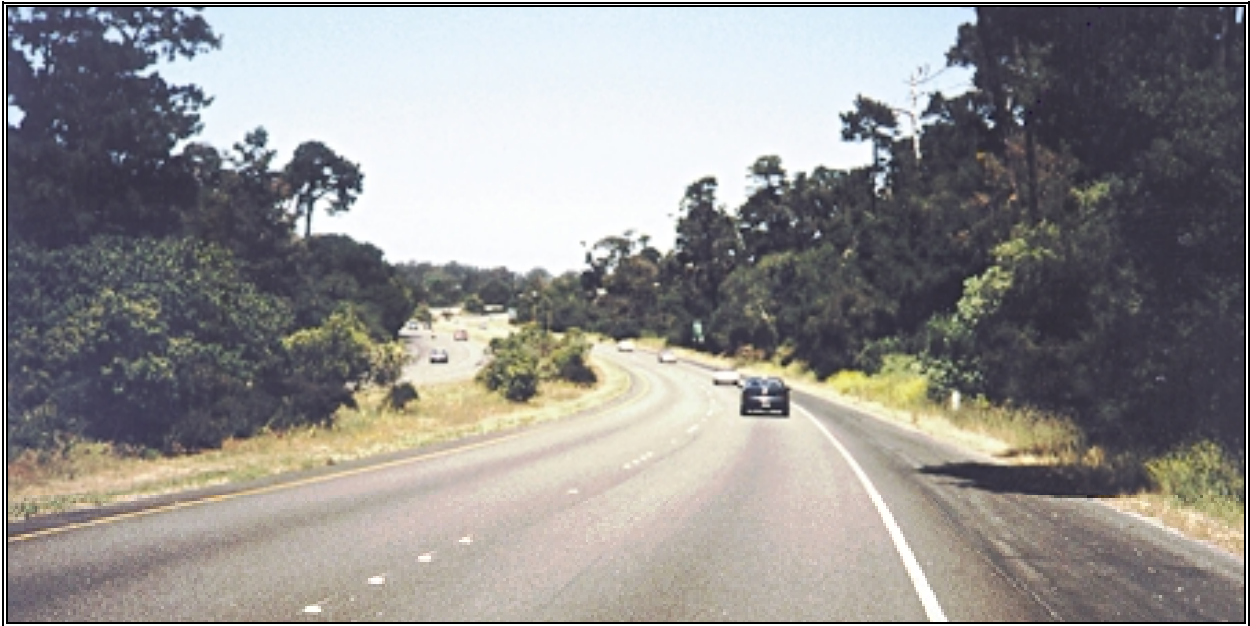
Observation Point #2

Northbound Approaching Aguajito Road Exit—Existing

The following sets of photographs (*pgs. 10 & 11*) identify two existing observation areas and illustrate how mitigation planting may appear, several years after construction.

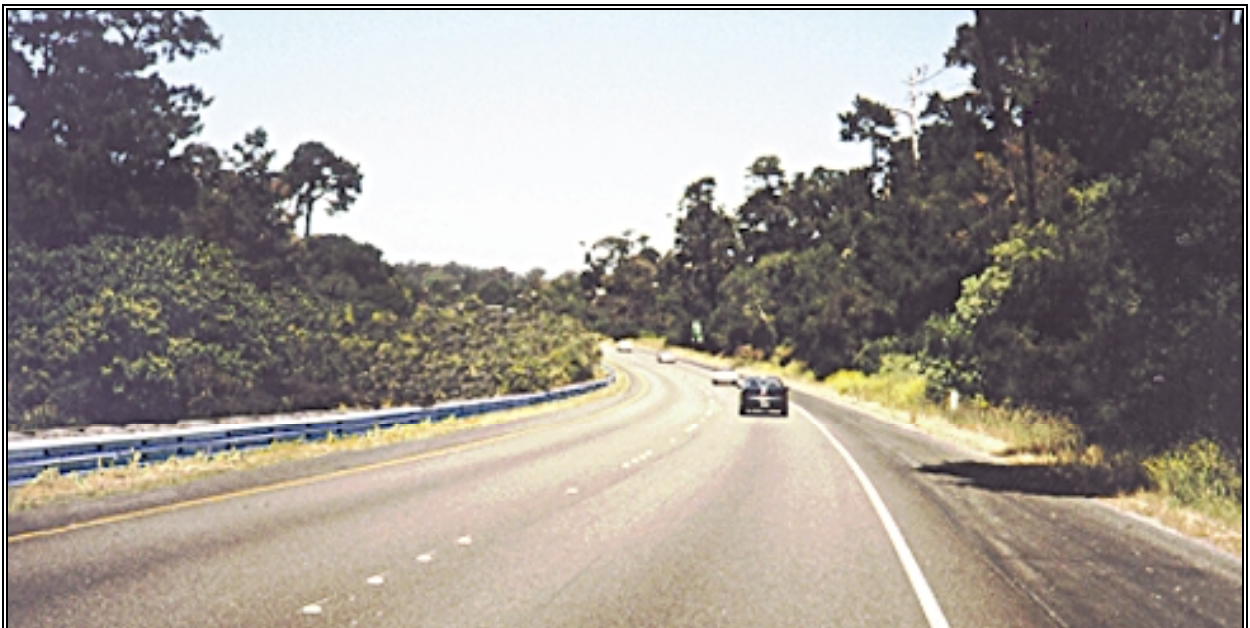
Observation Point #2

Northbound Approaching Aguajito Road Exit—several years after construction

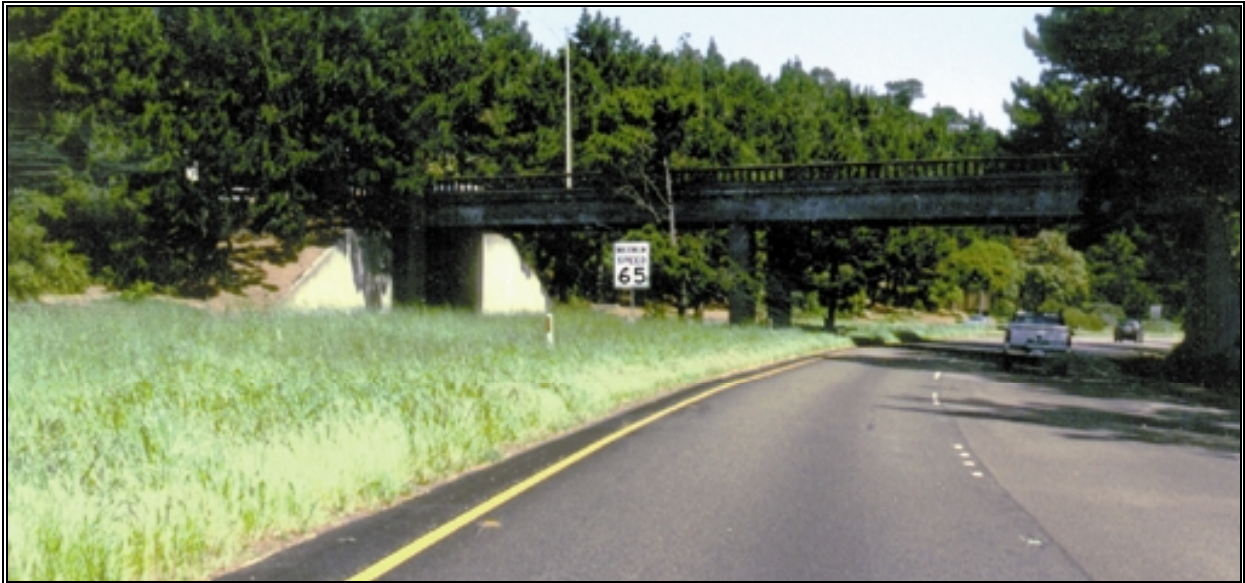
Observation Point #3

Northbound 68/01 South Separation—Existing

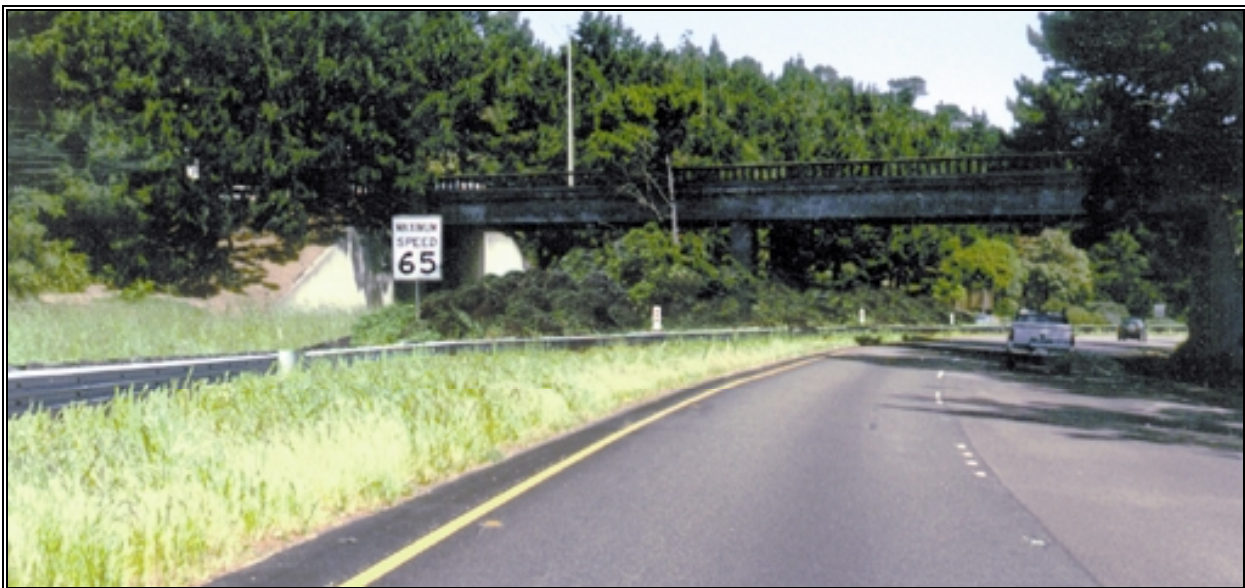
Observation Point #3

Northbound 68/01 South Separation— several years after construction
